Champlain Watershed Improvement Coalition of New York, Inc (CWICNY)

2008 Annual Report

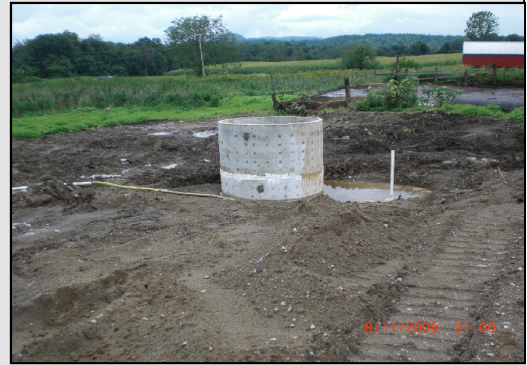
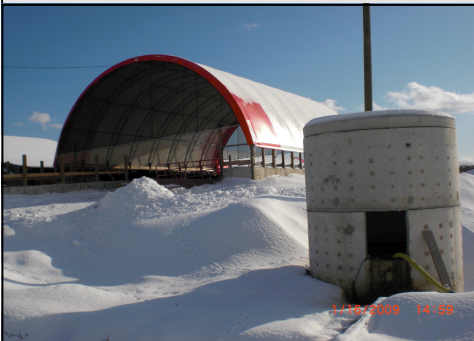
In cooperation with CWICNY, the Aid to Localities program and the Washington County Soil and Water Conservation District, two large farms, located in the Lake Champlain watershed of northern Washington County, have installed wastewater collection systems. The systems for each of the three participating farms are very similar, by design, to contain and treat rinse water discharged from milkhouse cleansings. Each system contains a 3,000 gallon concrete holding tank (shown in photos) which

Installation of Milk Center Wastewater Collection (Washington County)

Milk Center Wastewater system installed (Washington County)

is regularly emptied into a spreader for cropland application. Through land application, phosphorus and other nutrients are filtered through soil absorption and crop uptake.

Each farm has developed a Comprehensive Nutrient Management Plan (CNMP), a major component of a more comprehensive whole farm plan, required by NYS-DEC and US-EPA for all dairy farms of 200 or more cows. In each case, the farm's CNMP prescribed that the wastewater generated by daily milking operations be collected in a tank and pumped to a manure spreader for daily spreading, or to an adequate ag waste storage facility.

These systems replace the existing conditions where milk center waste either ran onto the ground, through grassy areas, or into a nearby ditch which often leads to a stream or other surface waterbody. Nutrient overloading and oxygen depletion typically resulting in streams from the effluent will no longer occur. These systems were designed and certified by a NYS Licensed Professional Engineer, with much of the planning and construction oversight provided by the Washington County SWCD staff.

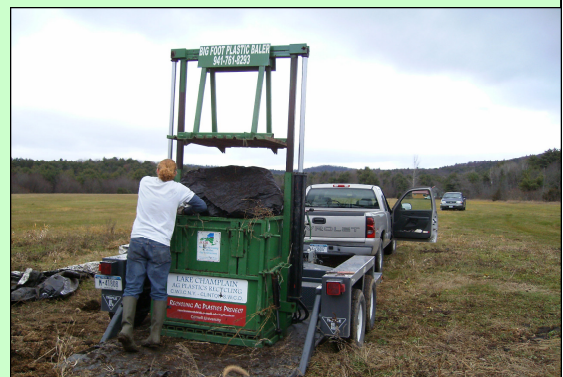
Hand-feeding ag plastics into the Plastics Baler [Clinton County]

The "Big Foot 300" agricultural plastics baler (photo) is actually modeled after a tobacco baler from the southern US. It has been modified to compress mountains of agricultural plastics scattered throughout the countryside. The baler is mounted on a hydraulic trailer which can be lowered to the ground for operations and raised for easy transport from farm to farm. A small air-cooled engine operates the hy-

draulic system necessary to compress the loose plastic into marketable 40 inch cubes. The 1,200lb bales of plastic will be recycled and reused in a variety of products including plastic lumber. Marketing this type of “dirty plastic” is difficult, and changing economic conditions require constant vigilance. Through the statewide and nationwide contacts of RAPP, the challenge of marketing has an optimum chance of success. The Ag Plastics program has generated intense media interest and television news exposure as well as numerous written articles across New York State, and parts of the Northeast. A number of hands-on educational demonstrations have thus far occurred in a variety of settings.

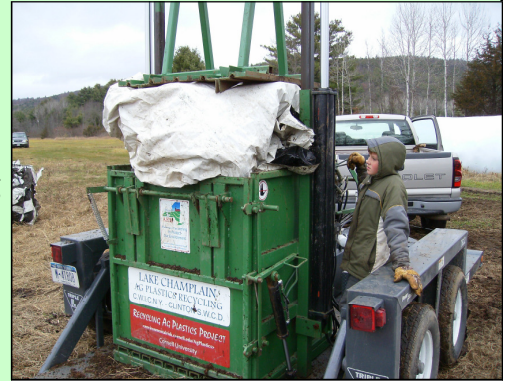
Compressing the Plastic into Bales. [Essex County]

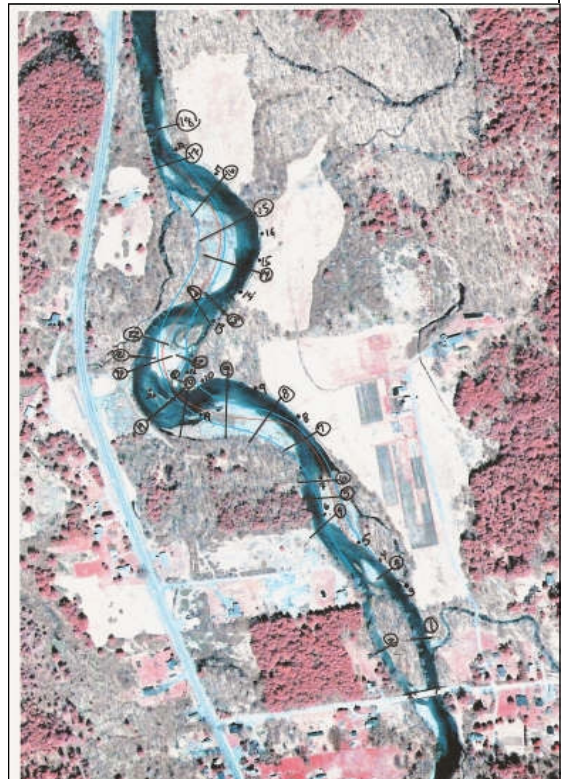
The area targeted for construction is a very unstable section of river (accompanying image) that has seen a tremendous amount of bank erosion. The erosion and streambank shifting in this section of the East Branch of the Ausable River was so severe after the original design was completed, a second survey was required for new stabilization plans.

Channel Stabilization Aerial View and Project Cross-Sections [Essex County]

The 2007-2008 Aid to Localities funds afforded Trout Unlimited and a private engineering firm the financial capability to complete an updated survey and design required to obtain permitting from the Adirondack Park Agency and NYS DEC. A funding match of 65% federal funds and 35% local funds was critical to obtain the new design.

The final planning phase is now complete with implementation of the new design slated to begin in 2009. The stabilization project will now be coordinated by the Army Corps of Engineers. When completed, this project will restore habitat, protect, and stabilize a highly erodible section of streambank on the majestic and rapid east branch of the Ausable River.

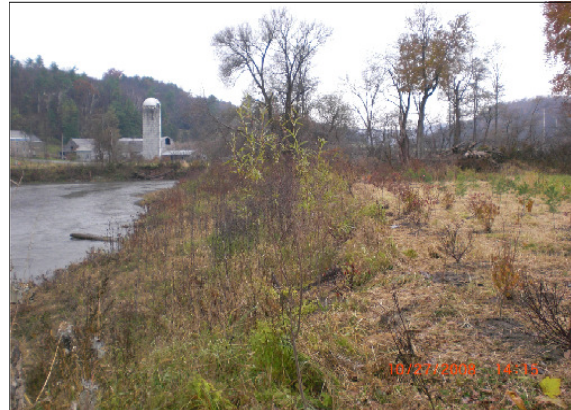
With funding through *Aid to Localities*, the project was expanded in 2008. The financial assistance through Aid to Localities allowed for an additional component of a riparian area (photo) to be completed at this site. The buffer area, 350 feet x45 feet, was planted with nearly 160 native tree and shrub seedlings providing additional streambank stabilization, surface water filtration, and habitat creation and restoration.

Newly established buffer and stabilization on Mettawee River. [Washington County]

Funding provided through the NYS Agricultural Nonpoint Source grant program allowed for installation of log retentions as well as a bankfull bench to stabilize the streambank at this site.

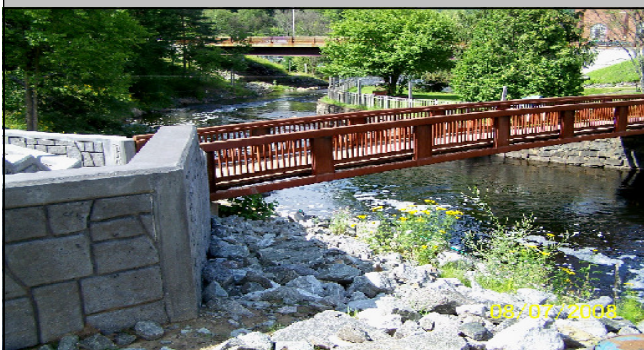
Sediments were continually being deposited into the river as a result of overland flow and bank instability. Angular stone was placed on the bank to prevent additional bank erosion and to filter out sediments transported during and after construction resulting in a massive reduction of sediment deposition into the Saranac River.

Post Construction Stabilization and Sediment Containment. River Walk, Saranac Lake.

Located in the Village of Saranac Lake on the Saranac River, this project was able to be completed in 2008 through funding provided by the *Aid to Localities* program. The final phase of this project included installation of a new access ramp to the footbridge as well as riverbank armoring along approximately 100 feet of the Saranac River. The armoring of the river bank was a much needed stabilization practice at this location where bank erosion on the Saranac River had posed a water quality issue for years.

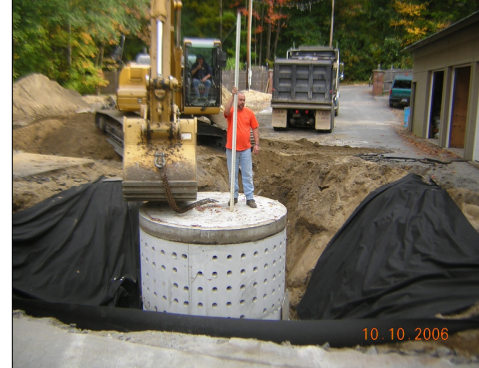
Installation of Stormwater Filtration System in Prospect Mountain Brook Watershed, Lake

The Warren County Soil and Water Conservation District has worked with the Village of Lake George DPW over a two year period to design and install over 20 separate stormwater improvement systems and streambank protection projects for the brook. The stormwater improvements consist of reworking the Village's existing storm drainage network to include the capturing of pollutants and the infiltration of runoff back into the ground. The stream restoration components included over 500 feet of channel protection efforts, which protect the stream from upland inputs and streambank erosion. With the completion of these projects, the amount of pollutants entering the stream and Lake George is significantly reduced.

Prospect Mountain Brook winds its way through the heart of the Village of Lake George, flowing between streets, parking lots and residential backyards eventually to its confluence with Lake George. Along its course, stormwater runoff pipes enter this stream, conveying road sands, salts and other pollutants into the brook. In addition to the pollutant inputs, the stream itself has seen considerable bank erosion, leading to excessive sediment reaching Lake George. These sediments and pollutants have been a concern for a long time, and have caused issues at the outlet with delta creation and navigation problems. However, thanks to funding through CWICNY's Aid to Localities grant, the NYS DEC, and the Lake George Association, most of these issues on Prospect Mountain Brook have been eliminated.

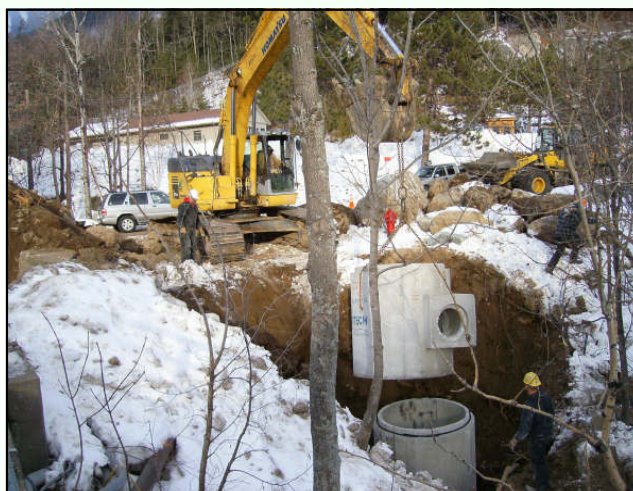
The Town of Wilmington was successful in securing a grant to install a *Vortex* unit to intercept stormwater and filter out sediments. However, the awarded funds would not cover the total project costs. The balance of required funding was provided through CWICNY's Aid to Localities resulting in the highly anticipated implementation of this critical project. The installation of the filtration units will dramatically reduce the high volume of sediments that run directly into the river from the upland areas and the parking lots.

Construction of Vortex Filtration Unit at Whiteface Mountain (above)

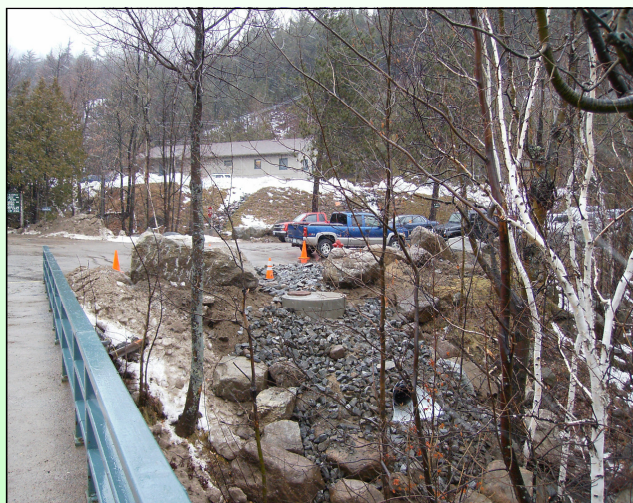
Vortex Unit Installed at Whiteface Mountain
